Update March 2017:

Juvenile Fish Bypass Construction, Adult PIT Arrays, and Monitoring of Post-construction Temperature Reduction and Sound/Vibration on Adult Salmon Passage through the Lower Granite ladder.

Lower Granite Juvenile Fish Bypass System (JFF Upgrade)

Post-construction Evaluation of Adult Fishway Temperature Differential Reduction at Lower Granite Dam in 2016

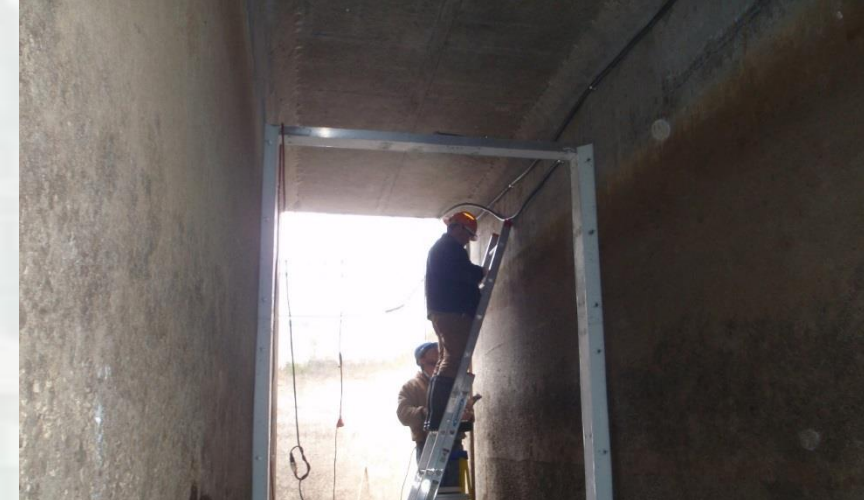
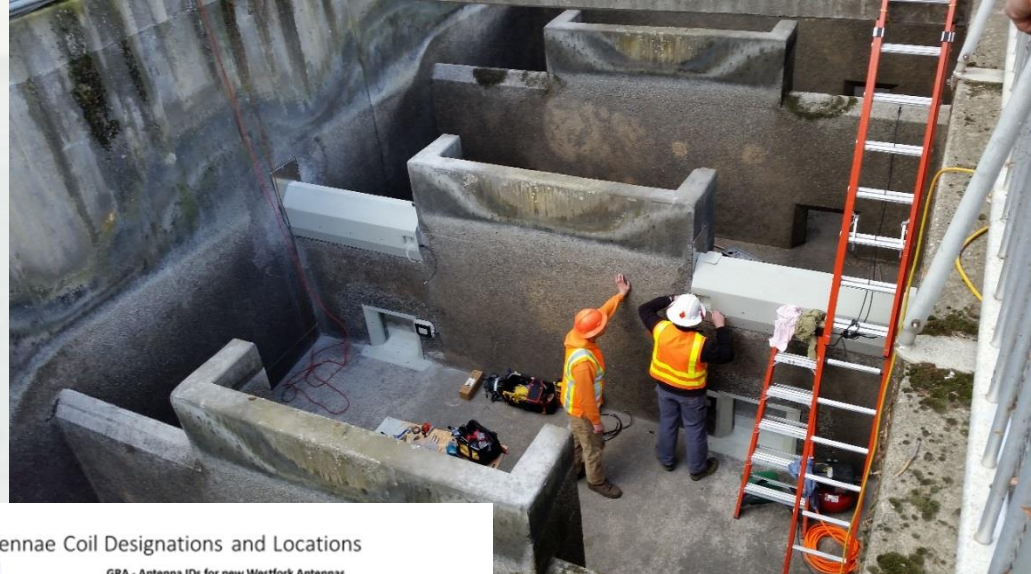
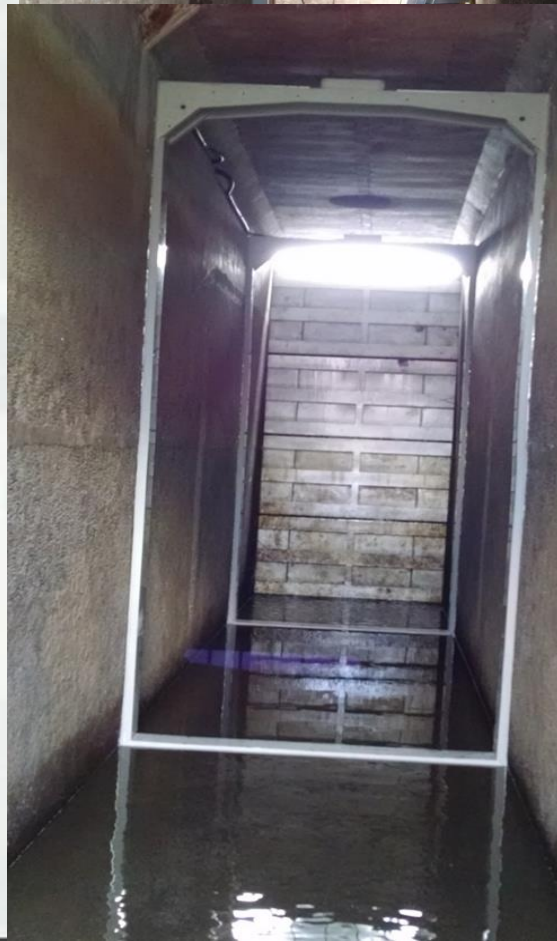
Lower Granite Dam PIT Antennae Coil Designations and Locations

Type	Antenna
Weir 730	Slot	1
Weir 731	Slot	3
Weir 732	Slot	5
Weir 733	Slot	7
Weir 730	Orifice	2
Weir 731	Orifice	4
Weir 732	Orifice	6
Weir 733	Orifice	8
Trap		12
Trap		14
Trap		16
Trap		18
Trap		22
Trap		24
Trap		26
Trap		28
Exit Pool top		A1
Exit Pool bottom		A2
Entrance orifice	Orifice	B3
Entrance orifice	Orifice	B4
Entrance weir	weir	B1
Entrance weir	weir	B2

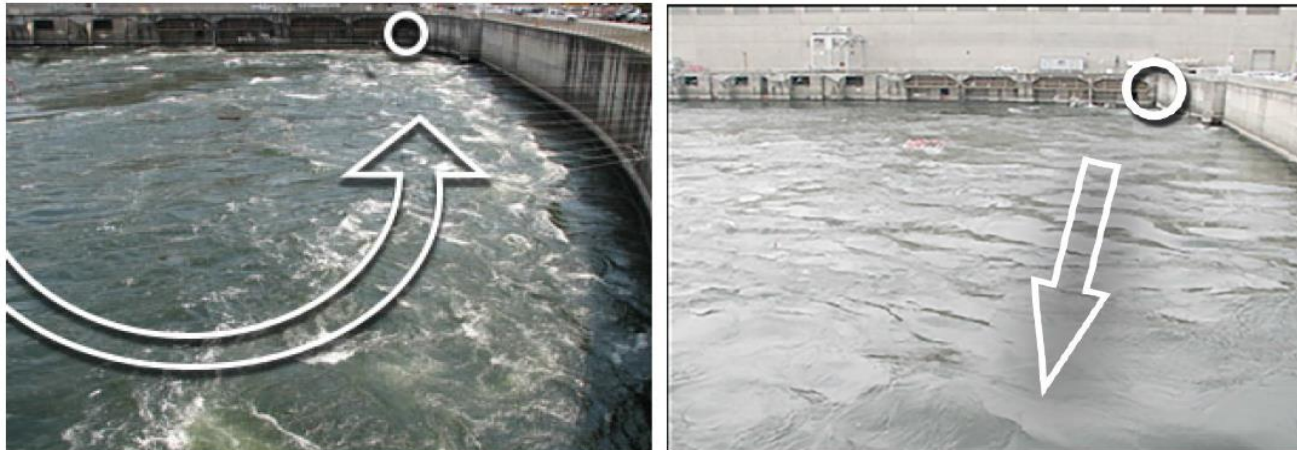
Figure 15. Tailrace conditions at Lower Granite Dam in July 2013 showing the reverse eddies with Turbine Unit 2 operating (left) and improved downstream flow with Unit 1 operating (right). Circles show ladder entrances. Arrow on the left shows the direction of the back eddies, which can confuse adults trying to orient into the current to move upstream. Arrows on the right show the direction of flow (away from the ladder entrance) without the reverse eddies. Photo courtesy of Darren Ogden (Northwest Fisheries Science Center).
